INSPECTOR GENERAL

OCTOBER 14, 2016

Summary Report – Inspections of DoD Facilities and Military Housing and Audits of Base Operations and Support Services Contracts

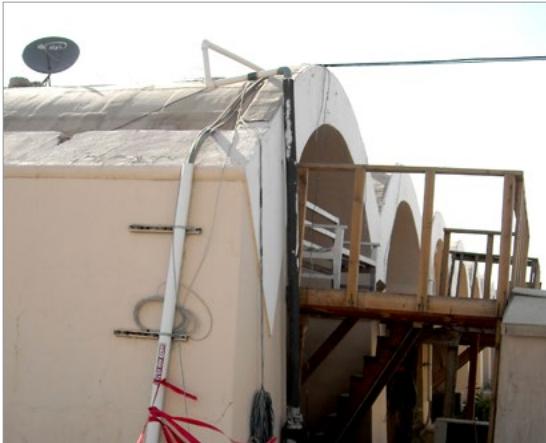
Figure 2. Live wires directly on roof at Kandahar Air Field, Afghanistan.
(Deficiency No. KAF-EL-120426-084)
Source: Report No. DODIG-2013-099

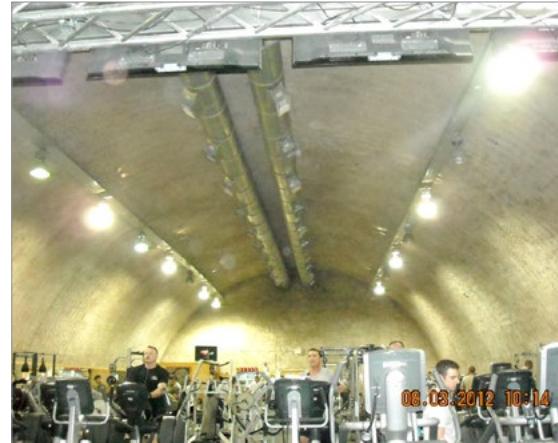
- missing or improperly installed smoke detectors, and
 - unencapsulated flammable insulation in multiple buildings (see Figure 3).

Figure 3. Unencapsulated flammable insulation at Bagram Air Field, Afghanistan.
(Deficiency No. BAF-FP-120709-241)
Source: Report No. DODIG-2013-099

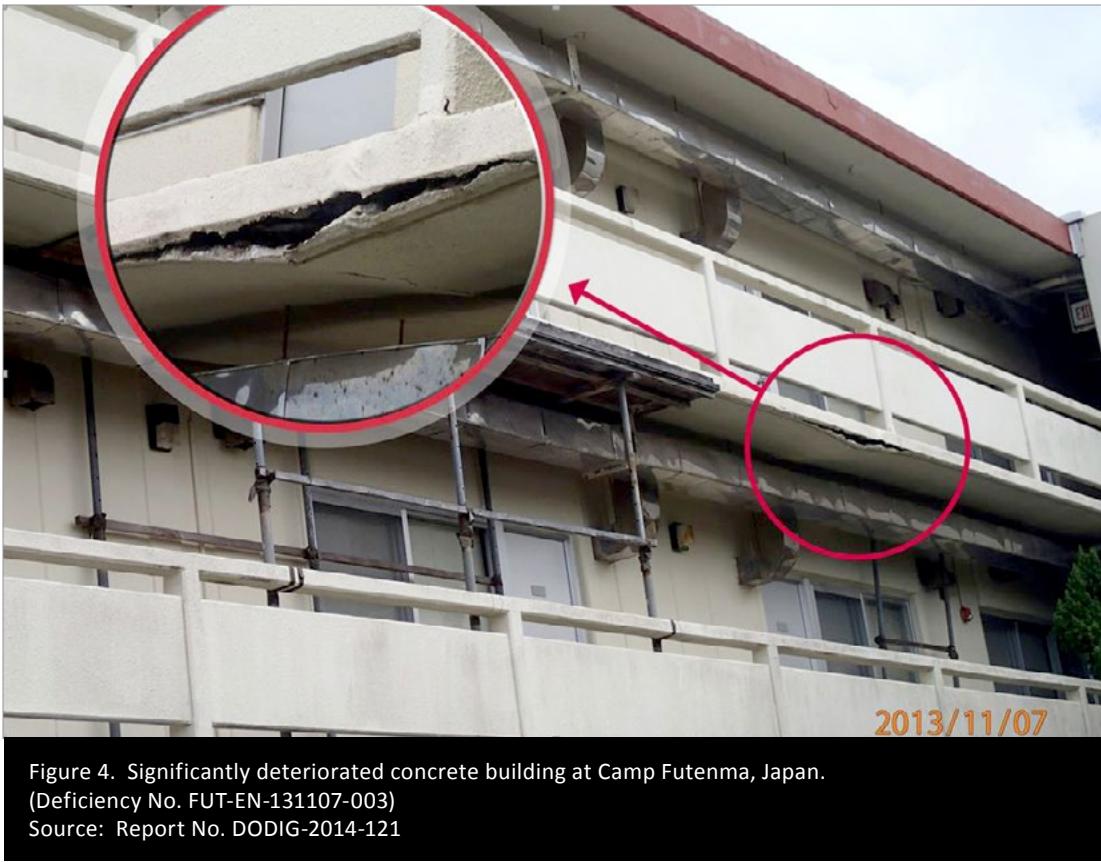
- a significantly deteriorated concrete building (see Figure 4) and a damaged and unsafe third-story exterior stair railing at another building (2 deficiencies); and
- unmitigated mold growth in multiple buildings and family housing units (9 deficiencies).

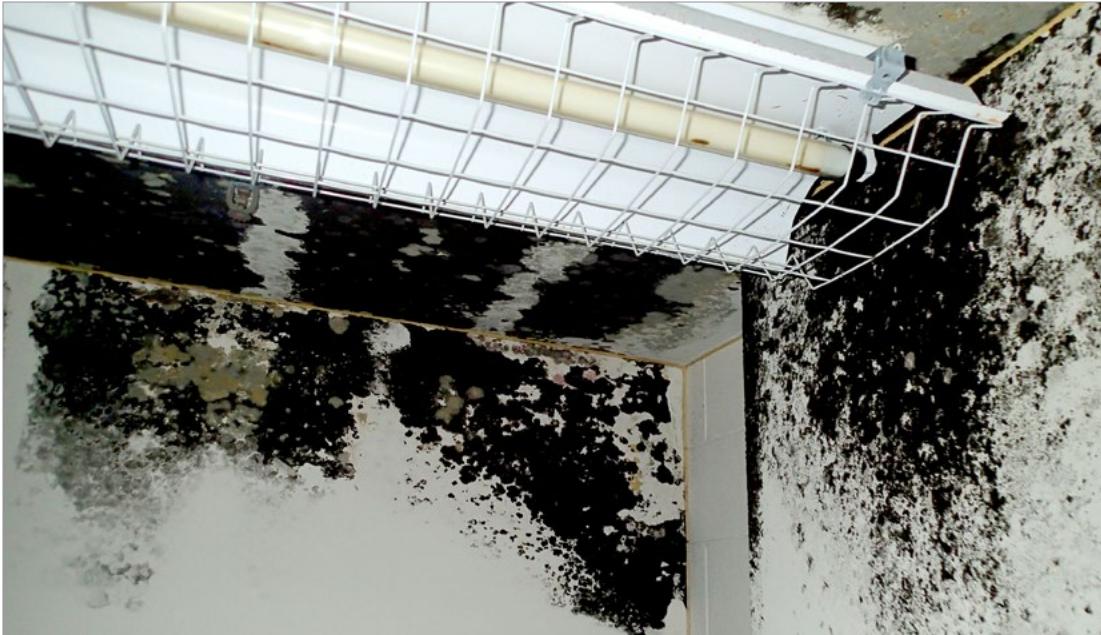
Figure 6. Unmitigated mold growth at Osan Air Base, Korea (not included in NOC).
(Deficiency No. OSA-EN-140407-007)

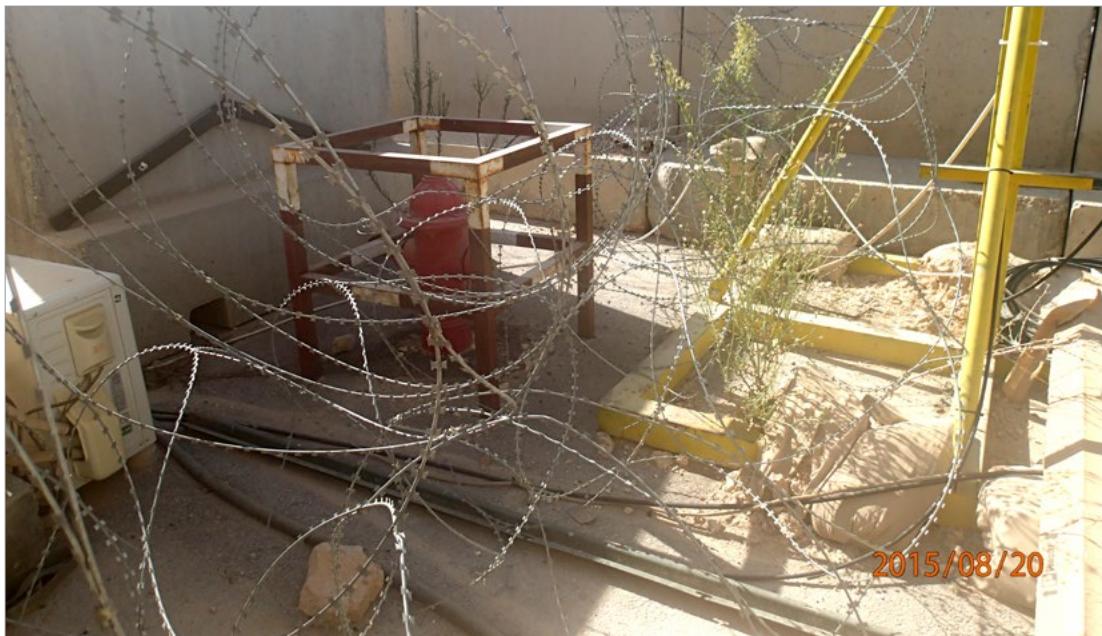
Figure 7. Obstructed fire hydrant at KASOTC, Jordan. (Deficiency No. KAS-FP-150828-137)
Source: Report No. DODIG-2016-106

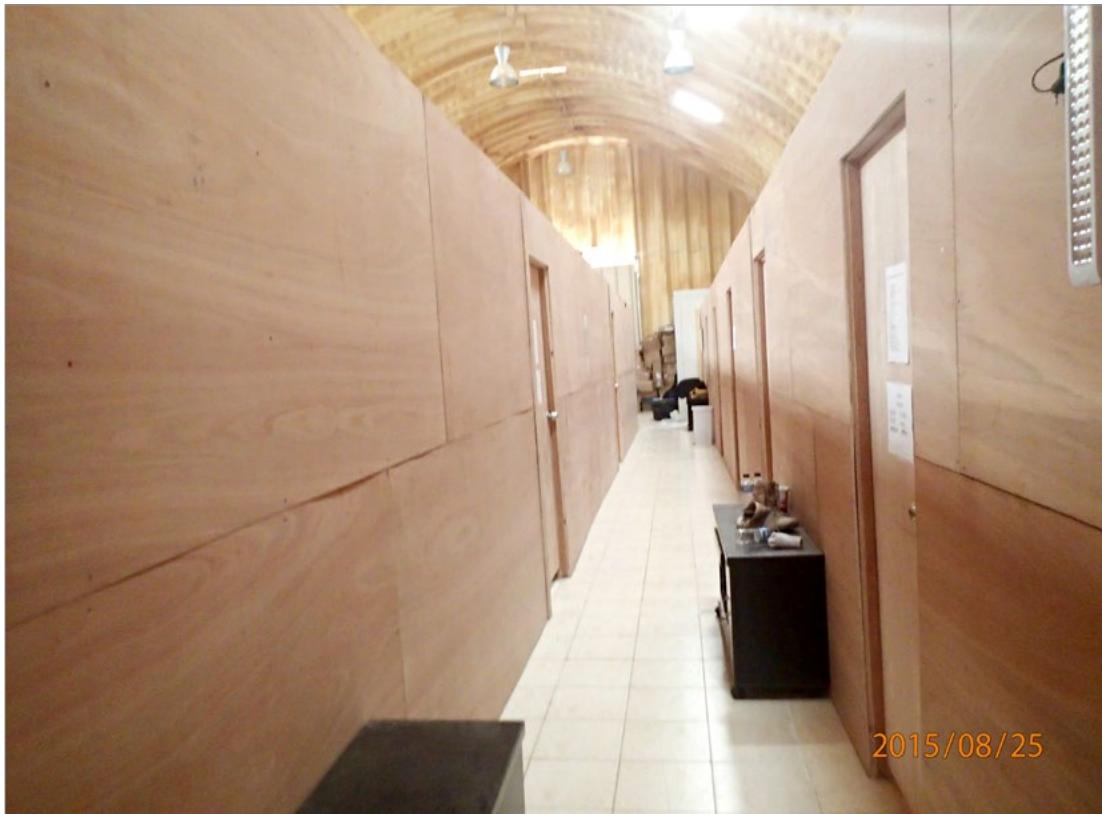
Figure 8. Building with no sprinklers that also lacked required fire-rated construction at KASOTC, Jordan.
(Deficiency No. KAS-FP-150828-134)
